**Flood Control Project Maintenance
Levee Inspections**

Maintenance Issue Types Only, Levee Inspection Report By Mile - Spring 2018

Sutter Maintenance Yard Maintenance Area 0013

Waterway	Bank	Unit Miles	Inspection Start/End	Inspector
Unit No. 01 Cherokee Canal	Right	18.19	04/17/2018 04/17/2018	Bob Duffey

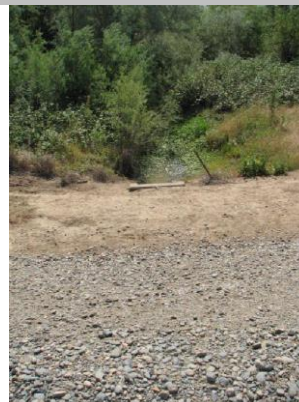
Photo 2 of 3 : UCIP_SP_2018_52219_66874.jpg

FS_ID:52219
DS_ID:16322
EP_NO: N/A
Repair Type: Non-Urgent
Crossing Status: Found
UCIP Comments: 6/14/2017 Both sides of the crossing were buried with sediment- needs to be cleared away. Pipe has been selected to be internally cleaned and inspected as part of the DMP project. (DWR Sutter Yard- A Freitag) 11/16/2016 WS flap gate is closed but is blocked from opening by sediment. (DWR Sutter Yard- A Freitag) 4/28/2016 Crossing appears to be in good condition. 7/13/2015 Minor sediment build up blocking flap gate from opening on WS. Needs to be dug out. 5/21/2014 Same as last inspection. 12/3/2013 Same as last inspection. 7/15/2013 Slopes are cleared of vegetation and are in good condition. WS flapgate is blocked from opening fully by sediment. 4/18/2012 Sediment build up on LS. Debris (broken panels) scattered near LS headwall. Limited inspection on WS and LS slope due to dense vegetation. Need photos of cleared WS and LS slopes.

View of WS slope and toe.

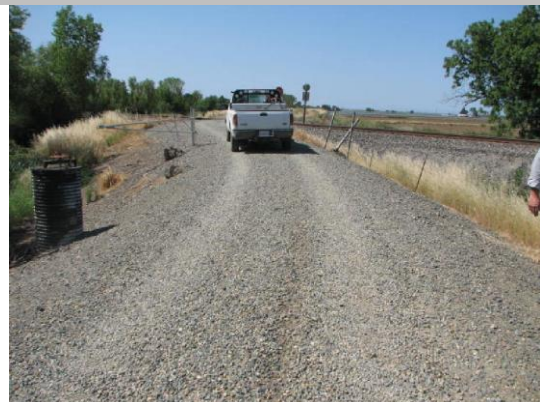
Photo 1 of 3 : UCIP_SP_2018_52223_66895.jpg

FS_ID:52223
DS_ID:16325
EP_NO: N/A
Repair Type: Non-Urgent
Crossing Status: Found
UCIP Comments: 6/14/2017 Debris drifts built up around the WS slide gates- needs to be cleared away. LS appears to be in good condition. Pipe has been selected to be internally cleaned and inspected as part of the DMP project. (DWR Sutter Yard- A Freitag)11/16/2016 Crossing appears to be in good condition. (DWR Sutter Yard- A Freitag)4/28/2016 Crossing appears to be in good condition.7/13/2015 Crossing appears in good condition. No noticeable issues to report.5/21/2014 Same as last inspection.12/3/2013 Same as last inspection.7/15/2013 LS slope has been sprayed and cleared of vegetation and is in good condition.4/18/2012 Limited inspection on LS slope due to dense vegetation. Need photo of cleared vegetation from slopes and WS headwall. Minor debris scattered on WS slope.
FIELD_STRUCT_DESC: 24-inch corrugated metal drainage pipe through the levee, 12.6 feet below the crown. Slide gate in corrugated metal pipe riser on the waterside (WS) slope. Slide gate on the WS end. Concrete "U" headwall on both ends. [Additional Reference(s): DWR Levee Log, 1993. USACE Sacramento O&M Manual 519, June 1962 (HLM 8.98)]

Overview of levee crown at crossing looking D/S.

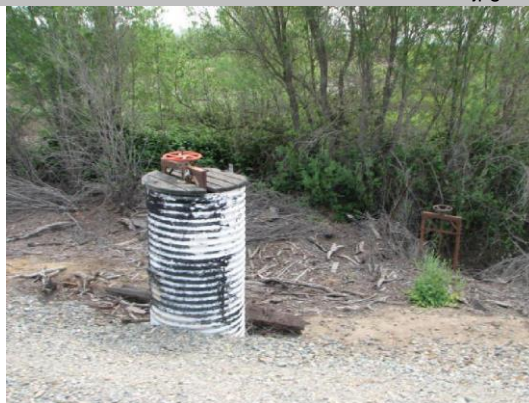
Photo 2 of 3 : UCIP_SP_2018_52223_66897.jpg

FS_ID:52223
DS_ID:16325
EP_NO: N/A
Repair Type: Non-Urgent
Crossing Status: Found
UCIP Comments: 6/14/2017 Debris drifts built up around the WS slide gates- needs to be cleared away. LS appears to be in good condition. Pipe has been selected to be internally cleaned and inspected as part of the DMP project. (DWR Sutter Yard- A Freitag) 11/16/2016 Crossing appears to be in good condition. (DWR Sutter Yard- A Freitag) 4/28/2016 Crossing appears to be in good condition. 7/13/2015 Crossing appears in good condition. No noticeable issues to report. 5/21/2014 Same as last inspection. 12/3/2013 Same as last inspection. 7/15/2013 LS slope has been sprayed and cleared of vegetation and is in good condition. 4/18/2012 Limited inspection on LS slope due to dense vegetation. Need photo of cleared vegetation from slopes and WS headwall. Minor debris scattered on WS slope.
FIELD_STRUCT_DESC: 24-inch corrugated metal drainage pipe through the levee, 12.6 feet below the crown. Slide gate in corrugated metal pipe riser on the waterside (WS) slope. Slide gate on the WS end. Concrete "U" headwall on both ends. [Additional Reference(s): DWR Levee Log, 1993. USACE Sacramento O&M Manual 519, June 1962 (HLM 8.98)]

View of WS slope with 2 slide gates.

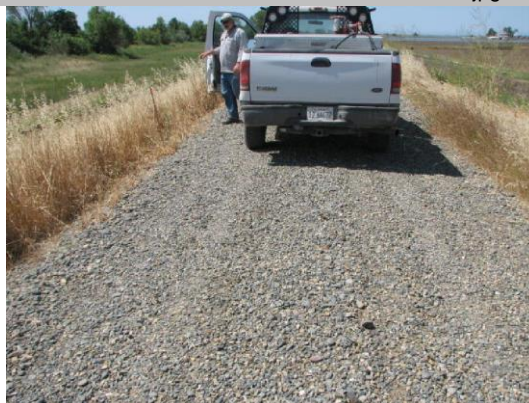
Photo 1 of 3 : UCIP_SP_2018_52227_66910.jpg

FS_ID:52227
DS_ID:16317
EP_NO: N/A
Repair Type: No Action Needed
Crossing Status: Found
UCIP Comments: 6/14/2017 Crossing appears to be in good condition. Pipe has been selected to be internally cleaned and inspected as part of the DMP project. (DWR Sutter Yard- AFreitag)11/16/2016 Crossing appears to be in good condition. (DWR Sutter Yard- AFreitag)4/28/2016 Crossing appears to be in good condition.7/13/2015 LS inlet has minor vegetation still. WS appears in good condition.5/21/2014 Same as last inspection.12/3/2013 Same as last inspection.7/15/2013 Slopes have been cleared of vegetation and are in good condition.4/18/2012 Limited inspection on WS and LS slopes due to dense vegetation. Need photos of cleared WS and LS slopes. This crossing was listed in the USACE Periodic Inspections as Corp's Insect ID# USACE_CESPK_M13D_2011_p_0278 for WS outlet sedimentation and sediment/grass at LS inlet. FIELD_STRUCT_DESC: 36-inch corrugated metal drainage pipe through the levee, 10.2 feet below the crown. Flap gate on the waterside (WS) end. Concrete "U" headwalls on both ends. Flashboards should be present on the landside (LS). [Additional Reference(s): DWR Levee Log, 1993. USACE Sacramento O&M Manual 519, June 1962 (HLM 9.09)]

Overview of levee crown at crossing looking downstream.

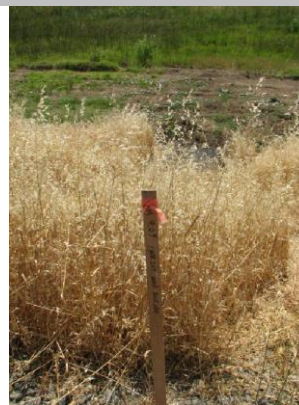
Photo 2 of 3 : UCIP_SP_2018_52227_66911.jpg

View of WS slope and toe.

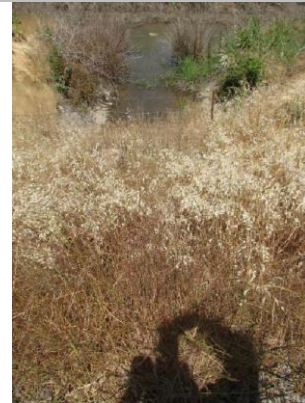
Photo 3 of 3 : UCIP_SP_2018_52227_66912.jpg

Item	DWR UCIP LMA Responsibility			39.476839 °	39.476839 °	
				-121.737540 °	-121.737540 °	
DWR ID						
Comment Code						
Inspector Comment						
FS_ID:52227 DS_ID:16317 EP_NO: N/A Repair Type: No Action Needed Crossing Status: Found UCIP Comments: 6/14/2017 Crossing appears to be in good condition. Pipe has been selected to be internally cleaned and inspected as part of the DMP project. (DWR Sutter Yard- AFreitag)11/16/2016 Crossing appears to be in good condition. (DWR Sutter Yard- AFreitag)4/28/2016 Crossing appears to be in good condition.7/13/2015 LS inlet has minor vegetation still. WS appears in good condition.5/21/2014 Same as last inspection.12/3/2013 Same as last inspection.7/15/2013 Slopes have been cleared of vegetation and are in good condition.4/18/2012 Limited inspection on WS and LS slopes due to dense vegetation. Need photos of cleared WS and LS slopes. This crossing was listed in the USACE Periodic Inspections as Corp's Insect ID# USACE_CESPK_M13D_2011_p_0278 for WS outlet sedimentation and sediment/grass at LS inlet. FIELD_STRUCT_DESC: 36-inch corrugated metal drainage pipe through the levee, 10.2 feet below the crown. Flap gate on the waterside (WS) end. Concrete "U" headwalls on both ends. Flashboards should be present on the landside (LS). [Additional Reference(s): DWR Levee Log, 1993. USACE Sacramento O&M Manual 519, June 1962 (HLM 9.09)] FS Date: 6/19/2017 1:09:21 PM

View of LS slope and toe.

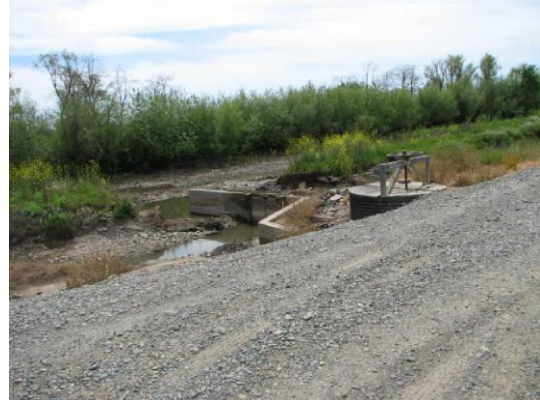
Photo 1 of 3 : UCIP_SP_2018_52232_66926.jpg

Comment Code					
Inspector Comment					
FS_ID:52232 DS_ID:16332 EP_NO: N/A Repair Type: No Action Needed Crossing Status: Found UCIP Comments: 6/15/2017 Crossing appears to be in good condition. Pipe has been selected to be internally cleaned and inspected as part of the DMP project. (DWR Sutter Yard- AFreitag)11/16/2016 Crossing appears to be in good condition. (DWR Sutter Yard- AFreitag)4/28/2016 Crossing appears to be in good condition.7/13/2015 Crossing appears in good condition. No noticeable issues to report.5/21/2014 Same as last inspection.12/3/2013 Same as last inspection.7/15/2013 Same as last inspection. FIELD_STRUCT_DESC: 60-inch corrugated metal drainage pipe through the levee, 11.5 feet below the crown. Slide gate in corrugated metal pipe riser on the waterside (WS) slope. Concrete "U" headwall on both ends and weir in channel. Crossing is used as an irrigation turnout. [Additional Reference(s): DWR Levee Log, 1993. USACE Sacramento O&M Manual 519, June 1962 (HLM 11.21)] FS Date: 6/19/2017 1:17:54 PM

View of WS corrugated metal riser and concrete wall.

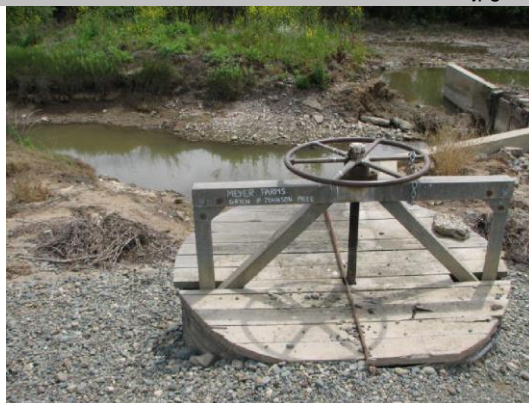
Photo 2 of 3 : UCIP_SP_2018_52232_66925.jpg

FS_ID:52232
DS_ID:16332
EP_NO: N/A
Repair Type: No Action Needed
Crossing Status: Found
UCIP Comments: 6/15/2017 Crossing appears to be in good condition. Pipe has been selected to be internally cleaned and inspected as part of the DMP project. (DWR Sutter Yard- AFreitag)11/16/2016 Crossing appears to be in good condition. (DWR Sutter Yard- AFreitag)4/28/2016 Crossing appears to be in good condition. 7/13/2015 Crossing appears in good condition. No noticeable issues to report. 5/21/2014 Same as last inspection. 12/3/2013 Same as last inspection. 7/15/2013 Same as last inspection.
FIELD_STRUCT_DESC: 60-inch corrugated metal drainage pipe through the levee, 11.5 feet below the crown. Slide gate in corrugated metal pipe riser on the waterside (WS) slope. Concrete "U" headwall on both ends and weir in channel. Crossing is used as an irrigation turnout. [Additional Reference(s): DWR Levee Log, 1993. USACE Sacramento O&M Manual 519, June 1962 (HLM 11.21)]

Corrugated metal riser with owner information.

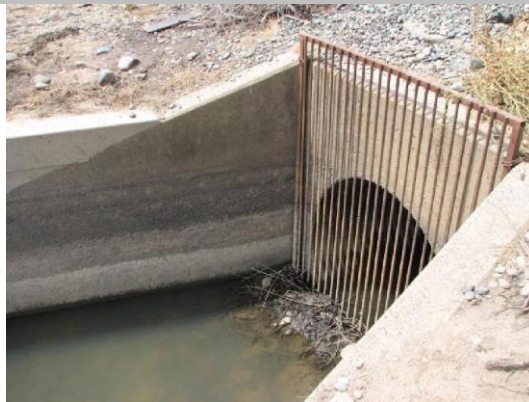
Photo 3 of 3 : UCIP_SP_2018_52232_66928.jpg

Trash rack on WS headwall.

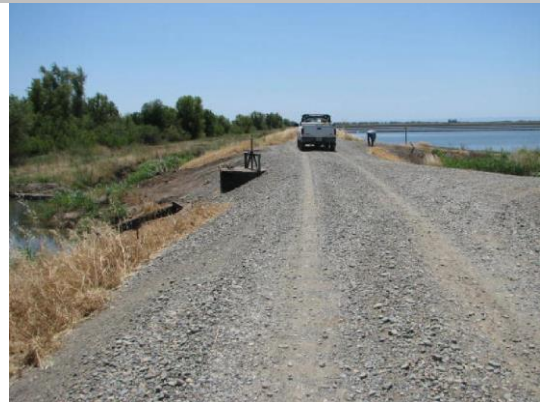
Photo 1 of 3 : UCIP_SP_2018_52233_66934.jpg

Comment Code					
Inspector Comment					
FS_ID:52233 DS_ID:16333 EP_NO: N/A Repair Type: No Action Needed Crossing Status: Found UCIP Comments: 6/15/2017 Crossing appears to be in good condition. Pipe has been selected to be internally cleaned and inspected as part of the DMP project. (DWR Sutter Yard- AFreitag)11/17/2016 Crossing appears to be in good condition. (DWR Sutter Yard- AFreitag)4/28/2016 Crossing appears to be in good condition.7/13/2015 Crossing appears in good condition. No noticeable issues to report.5/21/2014 Same as last inspection.12/3/2013 Same as last inspection.7/15/2013 Same as last inspection. FIELD_STRUCT_DESC: 60-inch corrugated metal drainage pipe through the levee, 11.3 feet below the crown. Slide gate in corrugated metal pipe riser on the waterside (WS) slope. Concrete "U" headwall on both ends. Crossing is used as an irrigation turnout bar code plate located on the WS slide gate (identified as 145). [Additional Reference(s): DWR Levee Log, 1993. USACE Sacramento O&M Manual 519, June 1962 (HLM 11.78)] FS Date: 6/19/2017 1:20:52 PM

Overview of levee crown at crossing looking downstream.

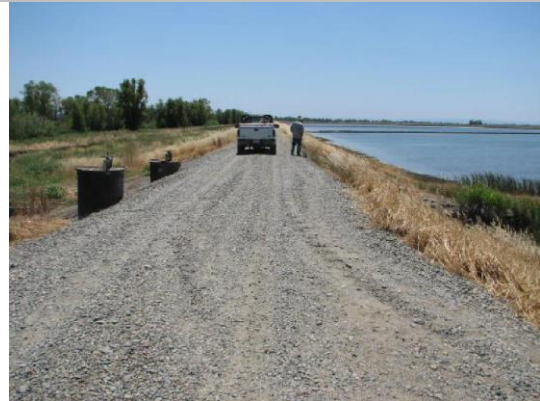
Photo 1 of 3 : UCIP_SP_2018_52234_66940.jpg

FS_ID:52234
DS_ID:16334
EP_NO: N/A
Repair Type: Non-Urgent
Crossing Status: Found
UCIP Comments: 6/15/2017 WS pipe end still unknown- try to locate using GPR/ utility locator. Pipe has been selected to be internally cleaned and inspected as part of the DMP project. (DWR Sutter Yard- A/Freitag)11/17/2016 Cannot locate the WS pipe end. (DWR Sutter Yard- A/Freitag)4/28/2016 Crossing appears to be in good condition but could not locate the WS pipe end.7/13/2015 New screw gate installed inside the WS standpipe. 5/21/2014 Same as last inspection.12/3/2013 Same as last inspection.7/15/2013 Slopes have been cleared of vegetation and are in good condition. Still no sign of WS end of pipe.4/18/2012 Limited inspection on WS and LS slope due to dense vegetation. WS outlet of pipe not found. Need photos of cleared WS and LS slopes. Determine if WS outlet daylight after WS slope is cleared.
FIELD_STRUCT_DESC: 30-inch corrugated metal drainage pipe through the levee, 11 feet below the crown. Slide gate in corrugated metal pipe riser on the waterside (WS) slope. Concrete "U" headwall on the landside (LS). [Additional Reference(s): DWR Levee Log, 1993. USACE Sacramento O&M Manual 519, June 1962 (HLM 12.38)]

Overview of levee crown at crossing looking downstream.

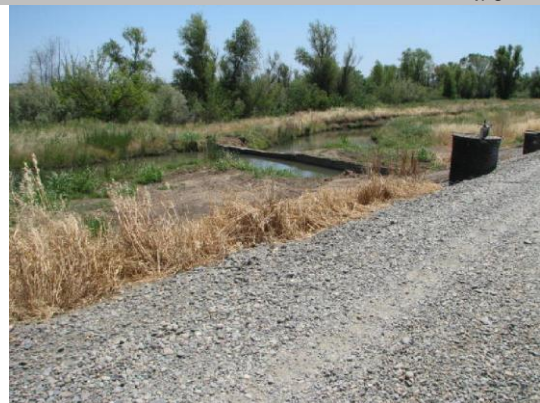
Photo 2 of 3 : UCIP_SP_2018_52234_66936.jpg

View of WS slope and channel.

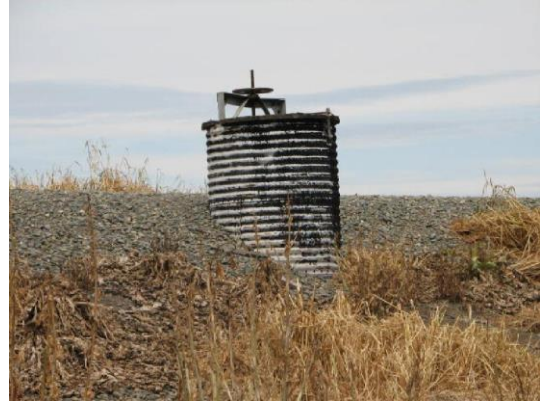
Photo 3 of 3 : UCIP_SP_2018_52234_66939.jpg

FS_ID:52234
DS_ID:16334
EP_NO: N/A
Repair Type: Non-Urgent
Crossing Status: Found
UCIP Comments: 6/15/2017 WS pipe end still unknown- try to locate using GPR/ utility locator. Pipe has been selected to be internally cleaned and inspected as part of the DMP project. (DWR Sutter Yard- A Freitag) 11/17/2016 Cannot locate the WS pipe end. (DWR Sutter Yard- A Freitag) 4/28/2016 Crossing appears to be in good condition but could not locate the WS pipe end. 7/13/2015 New screw gate installed inside the WS standpipe. 5/21/2014 Same as last inspection. 12/3/2013 Same as last inspection. 7/15/2013 Slopes have been cleared of vegetation and are in good condition. Still no sign of WS end of pipe. 4/18/2012 Limited inspection on WS and LS slope due to dense vegetation. WS outlet of pipe not found. Need photos of cleared WS and LS slopes. Determine if WS outlet daylight after WS slope is cleared.
FIELD_STRUCT_DESC: 30-inch corrugated metal drainage pipe through the levee, 11 feet below the crown. Slide gate in corrugated metal pipe riser on the waterside (WS) slope. Concrete "U" headwall on the landside (LS). [Additional Reference(s): DWR Levee Log, 1993. USACE Sacramento O&M Manual 519, June 1962 (HLM 12.38)]

Slide gate located on WS slope.

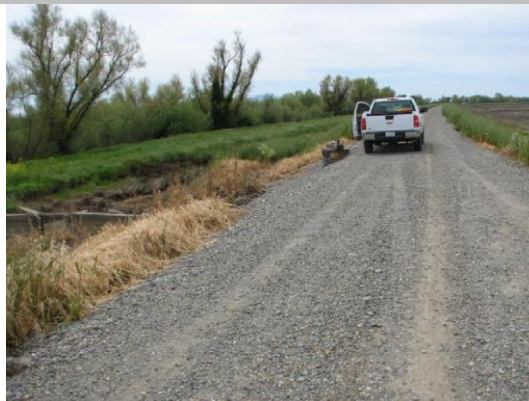
Photo 1 of 3 : UCIP_SP_2018_52236_66952.jpg

FS_ID:52236
DS_ID:16336
EP_NO: N/A
Repair Type: Non-Urgent
Crossing Status: Found
UCIP Comments: 6/15/2017 Slide gate still missing from inside of WS standpipe. Pipe has been selected to be internally cleaned and inspected as part of the DMP project. (DWR Sutter Yard- A/Freitag)11/17/2016 Slide gate still missing from inside the WS standpipe. (DWR Sutter Yard- A/Freitag)4/28/2016 Slide gate was removed from inside the WS standpipe.7/13/2015 New screw gate installed on the WS pipe end in the irrigation ditch.5/21/2014 Same as last inspection.12/3/2013 Same as last inspection.7/15/2013 Same as last inspection.4/18/2012 Irrigation turnout. Not in use during April 2012 Inspection. During the follow up May 2012 Inspection structure was being used as irrigation turnout, reason for barcode tags. FIELD_STRUCT_DESC: 30-inch corrugated metal drainage pipe through the levee, 10.7 feet below the crown. Slide gate in corrugated metal pipe (CMP) riser on the waterside (WS) slope. Concrete "U" headwalls on both ends. This crossing is used as an irrigation turnout bar code plate located on the WS slide gate (identified as 141 and 142). [Additional Reference(s): DWR Levee Log, 1993. USACE Sacramento O&M Manual 519, June 1962 (HLM 12.94)]

Overview picture looking south on right bank of Cherokee Canal.

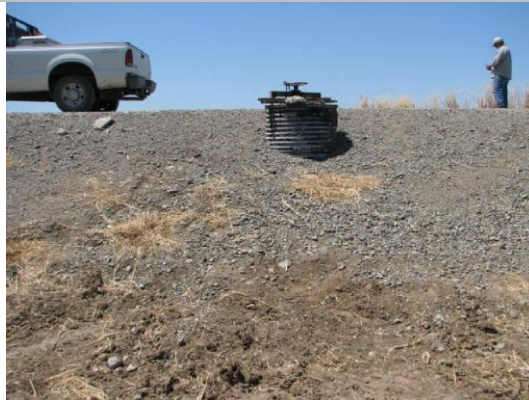
Photo 2 of 3 : UCIP_SP_2018_52236_66959.jpg

View of WS slope.

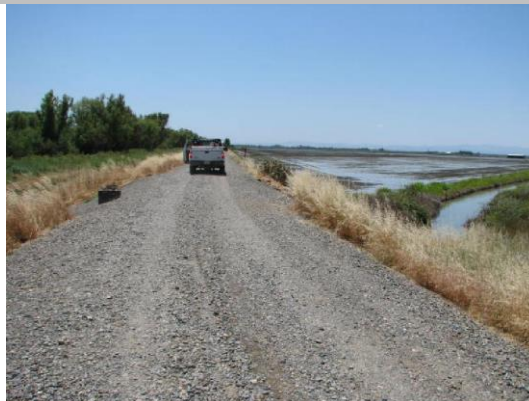
Photo 1 of 3 : UCIP_SP_2018_52238_66966.jpg

FS_ID:52238
DS_ID:16337
EP_NO: N/A
Repair Type: No Action Needed
Crossing Status: Found
UCIP Comments: 6/15/2017 Crossing appears to be in good condition. Pipe has been selected to be internally cleaned and inspected as part of the DMP project. (DWR Sutter Yard- A Freitag)11/17/2016 Ws pipe end was submerged but crossing appears to be in good condition. (DWR Sutter Yard- A Freitag)5/03/2016 Crossing appears to be in good condition.7/13/2015 New screwgate installed inside of WS standpipe.5/21/2014 Same as last inspection.12/3/2013 Same as last inspection.7/15/2013 Same as last inspection.
FIELD_STRUCT_DESC: 24-inch corrugated metal drainage pipe through the levee, 11.1 feet below the crown. Slide gate in corrugated metal pipe (CMP) riser on the waterside (WS) slope. Concrete "U" headwalls on both ends. [Additional Reference(s): DWR Levee Log, 1993. USACE Sacramento O&M Manual 519, June 1962 (HLM 13.53)]

Overview of levee crown at crossing looking downstream.

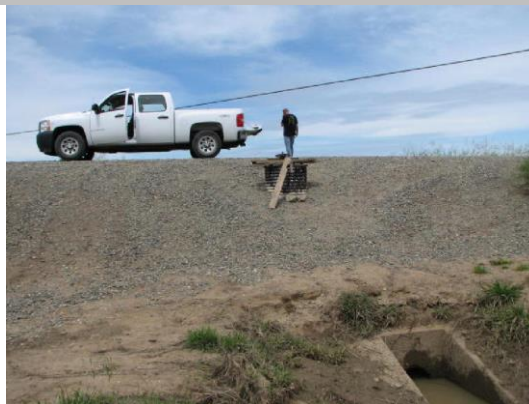
Photo 2 of 3 : UCIP_SP_2018_52238_66963.jpg

View of WS slope.

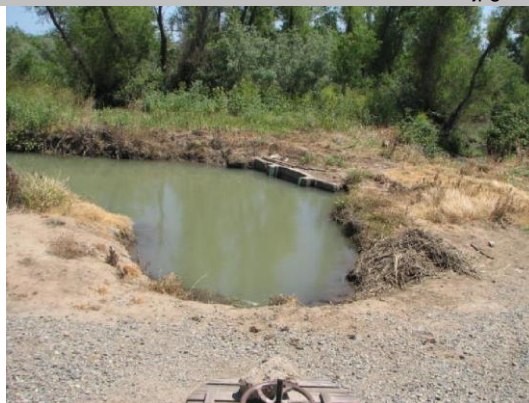
Photo 3 of 3 : UCIP_SP_2018_52238_66967.jpg

Item	DWR UCIP LMA Responsibility			39.420667 °	39.420667 °	
				-121.775700 °	-121.775700 °	
DWR ID						
Comment Code						
Inspector Comment						
FS_ID:52238 DS_ID:16337 EP_NO: N/A Repair Type: No Action Needed Crossing Status: Found UCIP Comments: 6/15/2017 Crossing appears to be in good condition. Pipe has been selected to be internally cleaned and inspected as part of the DMP project. (DWR Sutter Yard- A Freitag)11/17/2016 Ws pipe end was submerged but crossing appears to be in good condition. (DWR Sutter Yard- A Freitag)5/03/2016 Crossing appears to be in good condition.7/13/2015 New screwgate installed inside of WS standpipe.5/21/2014 Same as last inspection.12/3/2013 Same as last inspection.7/15/2013 Same as last inspection. FIELD_STRUCT_DESC: 24-inch corrugated metal drainage pipe through the levee, 11.1 feet below the crown. Slide gate in corrugated metal pipe (CMP) riser on the waterside (WS) slope. Concrete "U" headwalls on both ends. [Additional Reference(s): DWR Levee Log, 1993. USACE Sacramento O&M Manual 519, June 1962 (HLM 13.53)] FS Date: 6/19/2017 1:33:59 PM

View of WS slope and channel.

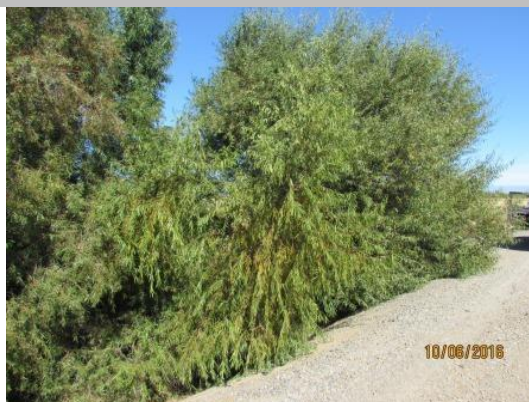
Photo 1 of 1 : SP_2018_MA0013_300_61_20180305_00011.jpg

LM Start	13.76	Rating **	U	Issue No.	61
LM End	13.76	Issue Type +	Ma	Location *	LS
Category	Earthen Levee			GPS Latitude/Longitude	
				Start	End
Item	Trim / Thin Trees			39.416854 °	39.416854 °
				-121.781855 °	-121.781855 °
DWR ID	DWR_MA0013_01_f_2016_61				
Comment Code					
T1 : Trim trees to at least five feet above ground level.					
Inspector Comment

View of the overgrown trees and vegetation along the landside slope and toe.

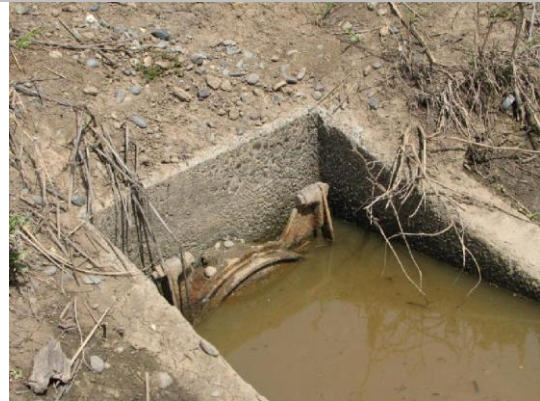
Photo 1 of 3 : UCIP_SP_2018_52239_66970.jpg

FS_ID:52239
DS_ID:16338
EP_NO: N/A
Repair Type: Urgent
Crossing Status: Found
UCIP Comments: 6/15/2017 Not abandoned- WS flapgate was dug out and opened draining water from the LS ditch. WS flapgate is heavily corroded and has a broken hinge- needs to be replaced. LS is still very overgrown and needs to be cleared. Pipe has been selected to be internally cleaned and inspected as part of the DMP project. (DWR Sutter Yard- A Freitag) 11/17/2016 Appears abandoned. WS flap gate completely silted over and LS screw gate is completely overgrown by a tree and is not accessible for inspection. (DWR Sutter Yard- A Freitag) 5/3/2016 Crossing appears to be abandoned. WS flap gate was completely silted over and LS slide gate is very overgrown by a tree. 7/13/2015 WS flap gate is blocked from opening by sediment and vegetation. Needs to be cleared away. LS opening is being overgrown by a tree and needs to be cutback. 5/22/2014 Same as last inspection. 12/3/2013 Same as last inspection. 7/15/2013 Same as last inspection. 4/18/2012 Tree has fallen at LS inlet and damaged slide gate. The tree needs to be removed and screw gate repaired. Limited inspection on LS due to fallen tree.

FIELD_STRUCT_DESC: 24-inch corrugated metal drainage pipe through the levee, 12.7 feet below the crown. Flap gate on the waterside (WS). Concrete "U" headwall on both ends. [Additional Reference(s): DWR Levee Log, 1993. USACE Sacramento O&M Manual 519, June 1962 (HLM 13.96)]
FS Date: 6/19/2017 1:43:53 PM

WS headwall and flap gate.

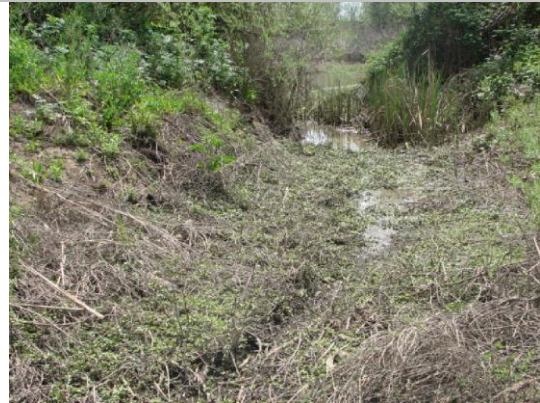
Photo 2 of 3 : UCIP_SP_2018_52239_66971.jpg

FS_ID:52239
DS_ID:16338
EP_NO: N/A
Repair Type: Urgent
Crossing Status: Found
UCIP Comments: 6/15/2017 Not abandoned- WS flapgate was dug out and opened draining water from the LS ditch. WS flapgate is heavily corroded and has a broken hinge- needs to be replaced. LS is still very overgrown and needs to be cleared. Pipe has been selected to be internally cleaned and inspected as part of the DMP project. (DWR Sutter Yard- A Freitag) 11/17/2016 Appears abandoned. WS flap gate completely silted over and LS screw gate is completely overgrown by a tree and is not accessible for inspection. (DWR Sutter Yard- A Freitag) 5/3/2016 Crossing appears to be abandoned. WS flap gate was completely silted over and LS slide gate is very overgrown by a tree. 7/13/2015 WS flap gate is blocked from opening by sediment and vegetation. Needs to be cleared away. LS opening is being overgrown by a tree and needs to be cutback. 5/22/2014 Same as last inspection. 12/3/2013 Same as last inspection. 7/15/2013 Same as last inspection. 4/18/2012 Tree has fallen at LS inlet and damaged slide gate. The tree needs to be removed and screw gate repaired. Limited inspection on LS due to fallen tree.

View of channel at crossing.

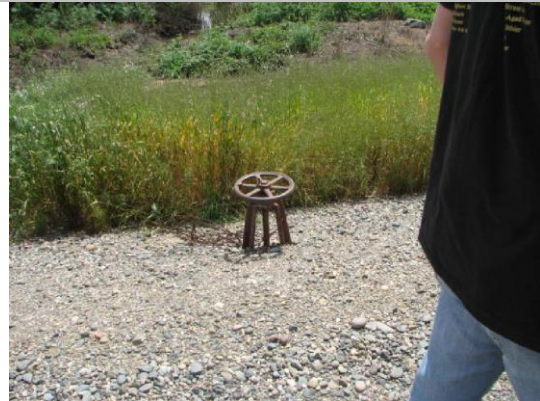
Photo 1 of 2 : UCIP_SP_2018_52240_66972.jpg

FS_ID:52240
DS_ID:16339
EP_NO: N/A
Repair Type: Non-Urgent
Crossing Status: Found
UCIP Comments: 6/15/2017 Abandoned- still only the structure on the WS shoulder found. (DWR Sutter Yard- A Freitag)11/17/2016 Abandoned. (DWR Sutter Yard- A Freitag)5/03/2016 ABANDONED CROSSING7/13/2015 Abandoned crossing. Slide gate is buried on the WS.5/22/2014 Same as last inspection.12/3/2013 Same as last inspection.7/15/2013 Same as last inspection.4/18/2012 Non-functional crossing-buried slide gate on WS. Limited inspection on WS and LS slope/toe due to dense vegetation. Need photo of cleared WS & LS slopes or toe. This crossing is listed in the USACE periodic inspection report as Corp's Inspection ID# USACE_CESPK_M13D_2011_p_0352 for abandoned gate on WS slope.
FIELD_STRUCT_DESC: *ABANDONED* 12-inch steel drainage pipe through the levee, 3 feet below the crown. Gate valve on the waterside (WS) slope. 0.25-inch steel plate welded on both ends. [Additional Reference(s): DWR Levee Log, 1993. USACE Sacramento O&M Manual 519, June 1962 (HLM 13.97)]

Buried slide gate on the WS slope.

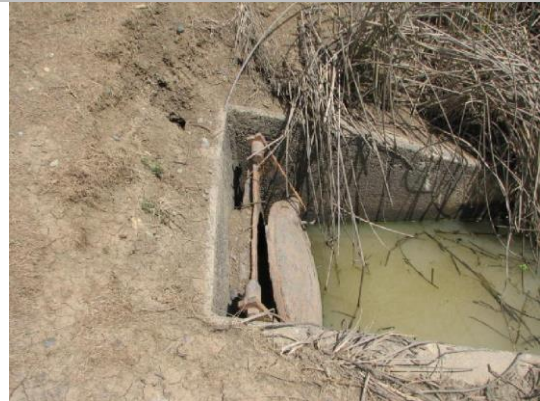
Photo 1 of 3 : UCIP_SP_2018_52241_66976.jpg

FS_ID:52241
DS_ID:16368
EP_NO: N/A
Repair Type: Urgent
Crossing Status: Found
UCIP Comments: 6/15/2017 WS pipe end still showing heavy signs of corrosion and deterioration with visible holes between the concrete headwall and flap gate flange. Pipe was almost 100% full of water so could not visually inspect inside of the pipe to see if theres any damage inside of the levee segment. Pipe has been selected to be internally cleaned and inspected as part of the DMP project. (DWR Sutter Yard - AFreitag)11/17/2016 Top of pipe on WS still showing heavy signs of corrosion with visible holes between the flapgate flange and the concrete headwall. The pipe was mostly underwater so could not internally inspect it for more damage or corrosion. (DWR Sutter Yard - AFreitag)5/03/2016 Top of the pipe on the WS has holes in it between the flapgate flange and headwall. Crossing is showing signs of rust and deterioration but it was mostly underwater so could not inspect the inside of the pipe. (DWR Sutter Yard - afreitag)7/13/2015 Both sides of crossing were underwater at the time of inspection. (DWR Sutter Yard - afreitag)5/22/2014 Same as last inspection. (DWR Sutter Yard - afreitag)12/3/2013 Same as last inspection. (DWR Sutter Yard - afreitag)7/15/2013 Slopes have been cleared of vegetation and are in good condition. WS flapgate is still lodged open. (DWR Sutter Yard - afreitag)4/18/2012 Limited inspection on LS slope due to dense vegetation. Need photos of cleared WS & LS slopes. The flap gate is lodged open. (DWR UCIP - omagana)

FIELD_STRUCT_DESC: 36-inch corrugated metal drainage pipe through the levee, 12.9 feet below the crown. Concrete "U" headwalls on both waterside (WS) and landside (LS) ends. Flap gate on the WS end. [Additional Reference(s): DWR Levee Log, 1993. USACE Sacramento O&M Manual 519, June 1962 (HLM 14.79)]
FS Date: 6/19/2017 1:55:54 PM

Headwall and flapgate located on water side of levee

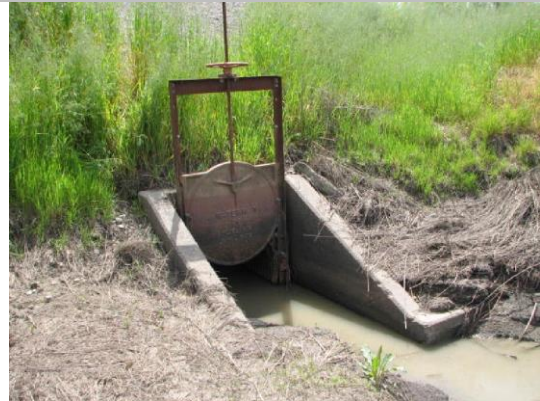
Photo 3 of 3 : UCIP_SP_2018_52241_66975.jpg

FS_ID:52241
DS_ID:16368
EP_NO: N/A
Repair Type: Urgent
Crossing Status: Found
UCIP Comments: 6/15/2017 WS pipe end still showing heavy signs of corrosion and deterioration with visible holes between the concrete headwall and flap gate flange. Pipe was almost 100% full of water so could not visually inspect inside of the pipe to see if theres any damage inside of the levee segment. Pipe has been selected to be internally cleaned and inspected as part of the DMP project. (DWR Sutter Yard - AFreitag)11/17/2016 Top of pipe on WS still showing heavy signs of corrosion with visible holes between the flapgate flange and the concrete headwall. The pipe was mostly underwater so could not internally inspect it for more damage or corrosion. (DWR Sutter Yard - AFreitag)5/03/2016 Top of the pipe on the WS has holes in it between the flapgate flange and headwall. Crossing is showing signs of rust and deterioration but it was mostly underwater so could not inspect the inside of the pipe. (DWR Sutter Yard - afreitag)7/13/2015 Both sides of crossing were underwater at the time of inspection. (DWR Sutter Yard - afreitag)5/22/2014 Same as last inspection. (DWR Sutter Yard - afreitag)12/3/2013 Same as last inspection. (DWR Sutter Yard - afreitag)7/15/2013 Slopes have been cleared of vegetation and are in good condition. WS flapgate is still lodged open. (DWR Sutter Yard - afreitag)4/18/2012 Limited inspection on LS slope due to dense vegetation. Need photos of cleared WS & LS slopes. The flap gate is lodged open. (DWR UCIP - omagana)

Head wall and screw gate located on land side of levee

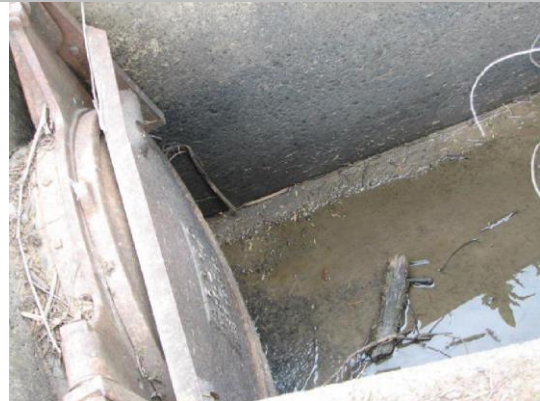
Photo 1 of 3 : UCIP_SP_2018_52242_66981.jpg

FS_ID:52242
DS_ID:16367
EP_NO: N/A
Repair Type: No Action Needed
Crossing Status: Found
UCIP Comments: 6/15/2017 Crossing appears to be in good condition. Pipe has been selected to be internally cleaned and inspected as part of the DMP project. (DWR Sutter Yard- AFreitag)11/17/2016 Crossing appears to be in good condition. (DWR Sutter Yard- AFreitag)5/03/2016 Crossing appears to be in good condition. 7/13/2015 Crossing appears in good condition. No noticeable issues to report. 5/22/2014 Same as last inspection. 12/3/2013 Same as last inspection. 7/15/2013 Slopes have been cleared of vegetation and are in good condition. 4/18/2012 Limited inspection on WS and LS slope due to dense vegetation. Need overall photo of crossing and photos of cleared WS & LS slopes. FIELD_STRUCT_DESC: 36-inch corrugated metal drainage pipe through the levee, 12.4 feet below the crown. Concrete "U" headwalls on both waterside (WS) and landside (LS). Flap gate on the waterside (WS) end. [Additional Reference(s): DWR Levee Log, 1993. USACE Sacramento O&M Manual 519, June 1962 (HLM 15.12)]

WS headwall and flapgate

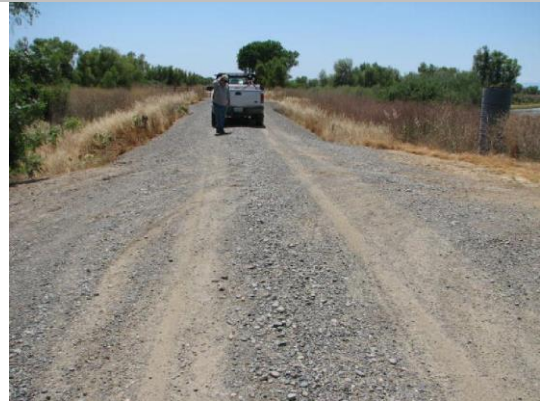
Photo 1 of 3 : UCIP_SP_2018_52243_66989.jpg

FS_ID:52243
DS_ID:16364
EP_NO: 7521
Repair Type: Non-Urgent
Crossing Status: Found
UCIP Comments: 6/15/2017 Both pipe ends completely submerged during site visit. Pipe has been selected to be internally cleaned and inspected as part of the DMP project. (DWR Sutter Yard- A/Freitag)11/17/2016 Both pipe ends underwater at time of inspection. (DWR Sutter Yard- A/Freitag)5/3/2016 Tree near the WS pipe end has been cut down. Stump is still in place. Water was too high to be able to see if the pipe inside was damaged. Minor erosion starting behind the WS headwall.7/13/2015 WS pipe end is heavily vegetated with trees and is making it almost impossible to inspect. Needs to be cleared out. LS appears in good condition.5/22/2014 Same as last inspection.12/3/2013 Same as last inspection.7/15/2013 Slopes have been cleared of vegetation and are in good condition.4/18/2012 Limited inspection on WS and LS slopes/toe due to dense vegetation. Erosion behind headwall on WS toe. Need photos of cleared WS & LS slopes.

Overview of levee crown at crossing looking downstream.

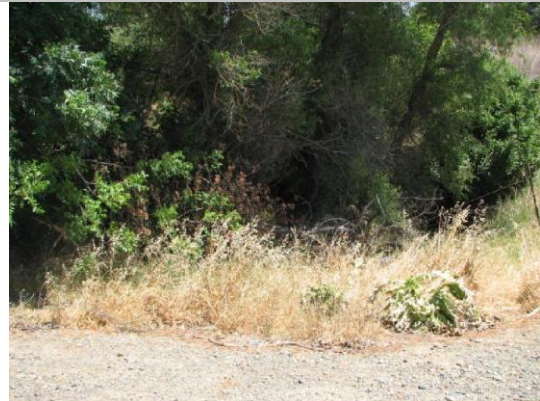
Photo 2 of 3 : UCIP_SP_2018_52243_66987.jpg

FS_ID:52243
DS_ID:16364
EP_NO: 7521
Repair Type: Non-Urgent
Crossing Status: Found
UCIP Comments: 6/15/2017 Both pipe ends completely submerged during site visit. Pipe has been selected to be internally cleaned and inspected as part of the DMP project. (DWR Sutter Yard-AFreitag)11/17/2016 Both pipe ends underwater at time of inspection. (DWR Sutter Yard- AFreitag)5/3/2016 Tree near the WS pipe end has been cut down. Stump is still in place. Water was too high to be able to see if the pipe inside was damaged. Minor erosion starting behind the WS headwall.7/13/2015 WS pipe end is heavily vegetated with trees and is making it almost impossible to inspect. Needs to be cleared out. LS appears in good condition.5/22/2014 Same as last inspection.12/3/2013 Same as last inspection.7/15/2013 Slopes have been cleared of vegetation and are in good condition.4/18/2012 Limited inspection on WS and LS slopes/toe due to dense vegetation. Erosion behind headwall on WS toe. Need photos of cleared WS & LS slopes.

View of WS.

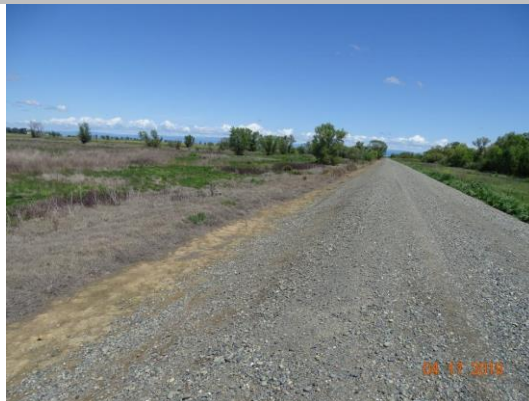
Photo 1 of 1 : SP_2018_MA0013_300_20_20180425_00147.jpg

LM Start	15.75	Rating **	A	Issue No.	20
LM End	18.50	Issue Type +	Ma	Location *	LS
Category	Earthen Levee			GPS Latitude/Longitude	
				Start	End
Item	Vegetation			39.398780 °	39.373430 °
				-121.810932 °	-121.850527 °
DWR ID	DWR_MA0013_01_s_2018_20				
Comment Code					
V1 : Control annual grass and weeds on the levee slopes and easements.					
Inspector Comment					
The vegetation was removed from the landside slope.

View of no vegetation along the landside slope.

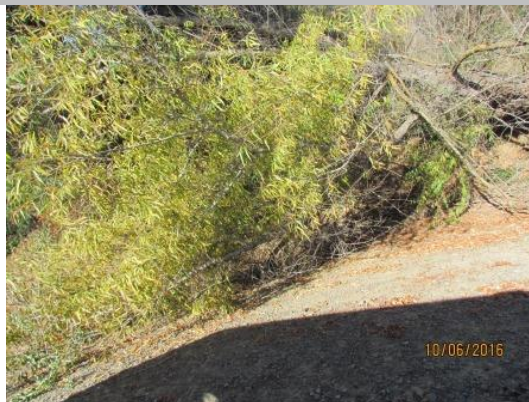
Photo 1 of 1 : SP_2018_MA0013_300_56_20180305_00009.jpg

LM Start	16.52	Rating **	M	Issue No.	56
LM End	16.52	Issue Type +	Ma	Location *	LS
Category	Earthen Levee			GPS Latitude/Longitude	
				Start	End
Item	Trim / Thin Trees			39.391675 °	39.391675 °
				-121.821932 °	-121.821932 °
DWR ID	DWR_MA0013_01_f_2016_56				
Comment Code					
T1 : Trim trees to at least five feet above ground level.					
Inspector Comment

View of dense trees along the landside toe.

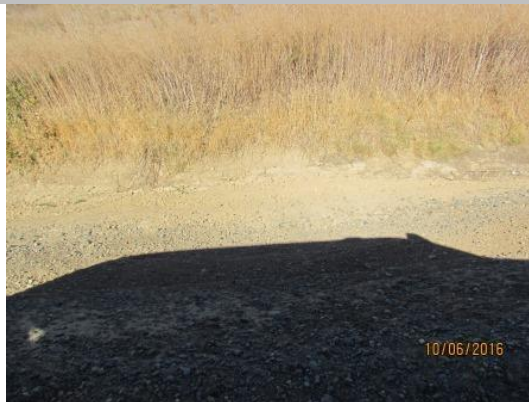
Photo 1 of 1 : SP_2018_MA0013_300_55_20180305_00008.jpg

LM Start	16.88	Rating **	M	Issue No.	55
LM End	16.88	Issue Type +	Ma	Location *	LS
Category	Earthen Levee			GPS Latitude/Longitude	
				Start	End
Item	Slope Stability			39.388326 °	39.388326 °
				-121.827137 °	-121.827137 °
DWR ID	DWR_MA0013_01_f _ 2016_55				
Comment Code					
S1 : Repair slope instability.					
Inspector Comment

View of slope instability issue along the landside slope.

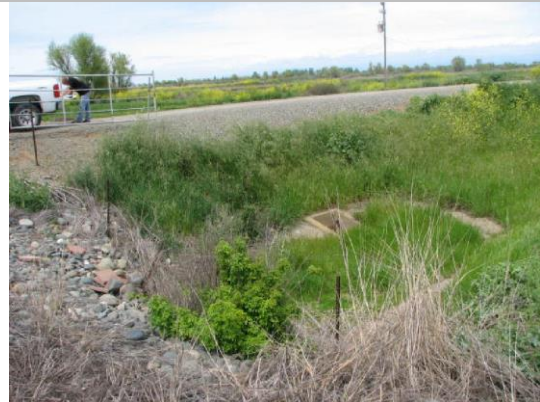
Photo 1 of 3 : UCIP_SP_2018_52249_67017.jpg

FS_ID:52249
DS_ID:16369
EP_NO: N/A
Repair Type: Non-Urgent
Crossing Status: Found
UCIP Comments: 6/15/2017 Flapgate bolted shut. Hinges seem very stiff to operate as gate will not fully close and has about a 1/2" gap near the top. Land owner claims the gate leaks during high water times. Pipe has been selected to be internally cleaned and inspected as part of the DMP project. (DWR Sutter Yard- A Freitag) 11/17/2016 Crossing appears to be in good condition. (DWR Sutter Yard- A Freitag) 5/03/2016 Crossing appears to be in good condition. 7/13/2015 WS flap gate is blocked from opening by sediment. Needs to be dug out. 5/22/2014 Same as last inspection. 12/3/2013 Sediment was dug out from WS flapgate allowing it to open. 7/15/2013 Slopes have been sprayed and cleared of vegetation and are in good condition. WS flapgate is blocked from opening by sediment buildup. 4/18/2012 Limited inspection on WS and LS slope due to dense vegetation and steep slopes. Need photos of cleared WS & LS slopes.

View of WS slope and toe.

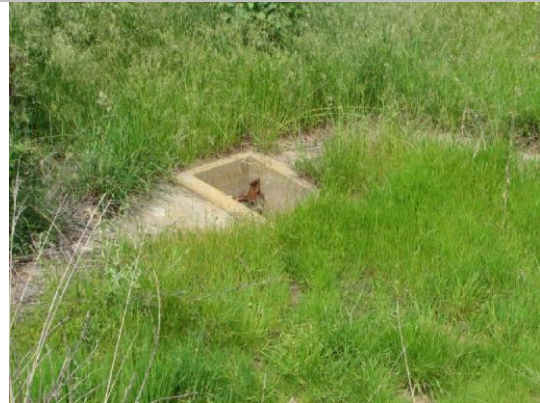
Photo 2 of 3 : UCIP_SP_2018_52249_67019.jpg

FS_ID:52249
DS_ID:16369
EP_NO: N/A
Repair Type: Non-Urgent
Crossing Status: Found
UCIP Comments: 6/15/2017 Flapgate bolted shut. Hinges seem very stiff to operate as gate will not fully close and has about a 1/2" gap near the top. Land owner claims the gate leaks during high water times. Pipe has been selected to be internally cleaned and inspected as part of the DMP project. (DWR Sutter Yard- A Freitag) 11/17/2016 Crossing appears to be in good condition. (DWR Sutter Yard- A Freitag) 5/03/2016 Crossing appears to be in good condition. 7/13/2015 WS flap gate is blocked from opening by sediment. Needs to be dug out. 5/22/2014 Same as last inspection. 12/3/2013 Sediment was dug out from WS flapgate allowing it to open. 7/15/2013 Slopes have been sprayed and cleared of vegetation and are in good condition. WS flapgate is blocked from opening by sediment buildup. 4/18/2012 Limited inspection on WS and LS slope due to dense vegetation and steep slopes. Need photos of cleared WS & LS slopes.

View of WS headwall and flap gate.

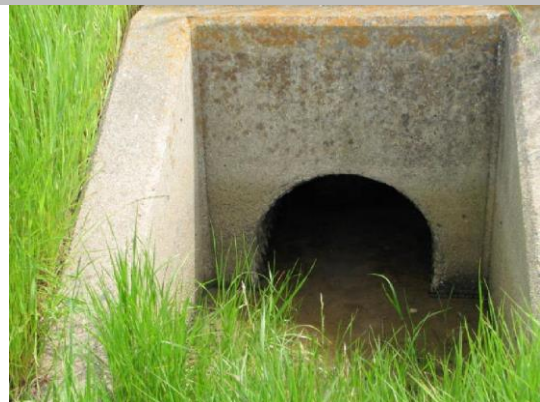
Photo 3 of 3 : UCIP_SP_2018_52249_67018.jpg

View of LS headwall.

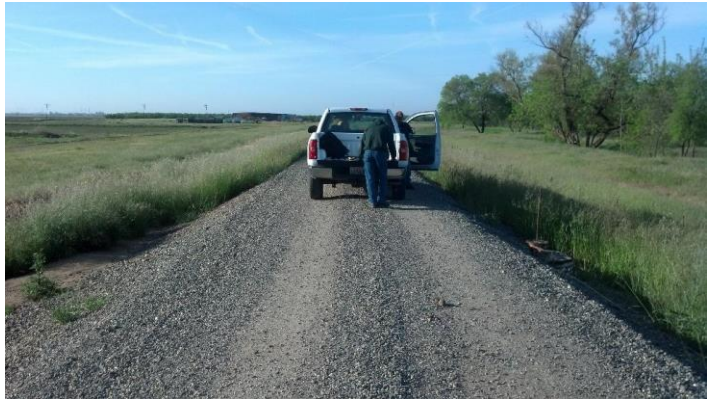
Photo 1 of 3 : UCIP_SP_2018_52112_67047.jpg

FIELD_STRUCT_DESC: 24-inch corrugated metal drainage pipe through the levee, 10.6 feet below the crown. Slide gate in corrugated metal pipe (CMP) riser on the waterside (WS) slope. Concrete "U" headwall on the landside (LS). 36-inch concrete standpipe in the channel with two wooden piles to deflect debris. [Additional Reference(s): DWR Levee Log, 1993. USACE Sacramento O&M Manual 519, June 1962 (HLM 0.57)]
FS Date: 6/7/2017 12:03:30 PM

Overview looking south

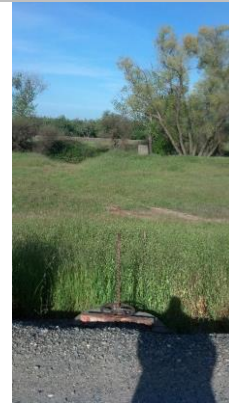
Photo 2 of 3 : UCIP_SP_2018_52112_67048.jpg

View of WS slope and toe.

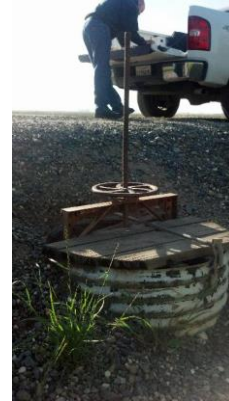
Photo 3 of 3 : UCIP_SP_2018_52112_67045.jpg

FS_ID:52112
DS_ID:16398
EP_NO: N/A
Repair Type: Non-Urgent
Crossing Status: Found
UCIP Comments: 6/5/2017 LS ditch at outlet is getting overgrown with vegetation. WS near concrete standpipe is overgrown with vegetation. Pipe has been selected to be internally cleaned and inspected as part of the DMP project. (DWR Sutter Yard- AFreitag)11/18/2016 Between the screwgate on the WS shoulder and the LS pipe end the pipe is about 50% full of soil. Crossing is still actively used by landowner for irrigation purposes. (DWR Sutter Yard- AFreitag)4/27/2016 Pipe gets used by the landowner to irrigate his rice fields. It appeared to be in good condition.7/01/2015 LS pipe end is still about 50% full of sediment.5/29/2014 Same as last inspection.12/9/2013 Same as last inspection.7/10/2013 LS and WS slopes have been cleared of vegetation and are in good condition. LS pipe end is half full of sediment. Sediment inside of WS standpipe may hinder slide gate from fully closing. Standpipe cover is still broken.4/19/2012 Need to fix the top of slide gate cover. The wooden cap on standpipe is broken. Limited evaluation of crossing due to dense vegetation on LS slope. Need photos of cleared slopes during fall inspection.

Screw gate located on WS of levee. Screw gate covers needs to be repaired.

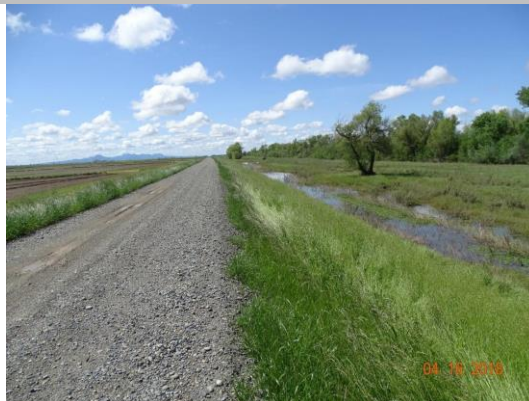
Photo 1 of 1 : SP_2018_MA0013_301_77_20180425_00139.jpg

LM Start	0.59	Rating **	M	Issue No.	77
LM End	22.34	Issue Type +	Ma	Location *	WS
Category	Earthen Levee			GPS Latitude/Longitude	
				Start	End
Item	Vegetation			39.566287 °	39.358318 °
				-121.702435 °	-121.875355 °
DWR ID	DWR_MA0013_02_s_2018_77				
Comment Code					
V1 : Control annual grass and weeds on the levee slopes and easements.					
Inspector Comment					
Trim the native vegetation on the waterside slope.

View of the native vegetation along the waterside slope.

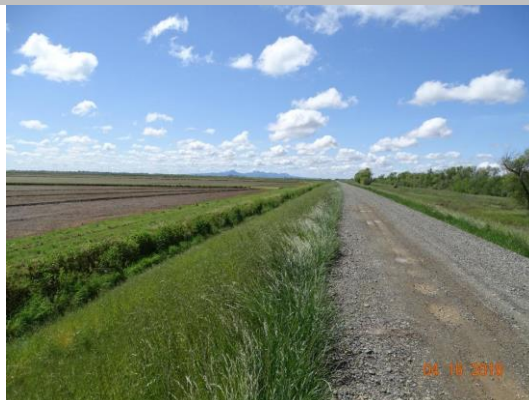
Photo 1 of 1 : SP_2018_MA0013_301_76_20180425_00138.jpg

LM Start	1.63	Rating **	M	Issue No.	76
LM End	17.21	Issue Type +	Ma	Location *	LS
Category	Earthen Levee			GPS Latitude/Longitude	
				Start	End
Item	Vegetation			39.551775 °	39.403280 °
				-121.704725 °	-121.799552 °
DWR ID	DWR_MA0013_02_s_2018_76				
Comment Code					
V1 : Control annual grass and weeds on the levee slopes and easements.					
Inspector Comment					
Trim the native vegetation on the landside slope.

View of the native vegetation along the landside slope.

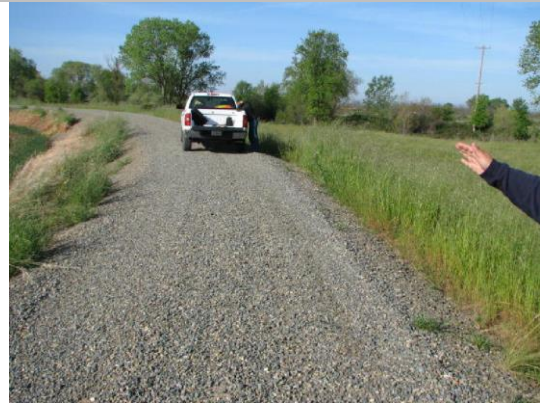
Photo 1 of 3 : UCIP_SP_2018_52114_67059.jpg

FS_ID:52114
DS_ID:16399
EP_NO: N/A
Repair Type: Non-Urgent
Crossing Status: Found
UCIP Comments: 6/5/2017 LS slide gate stem is bent and the gate appears as if it will not open. LS inlet is becoming heavily vegetated next to rice field. WS flap gate is blocked shut by sediment. Pipe has been selected to be internally cleaned and inspected as part of the DMP project. (DWR Sutter Yard- AFreitag)11/18/2016 LS screw gate still bent and in-operable. (DWR Sutter Yard- AFreitag)4/27/2016 LS screw gate is still bent. Rest of crossing appeared in good condition.7/01/2015 LS screw gate frame is still twisted and hindering the gate from opening.5/29/2014 Same as last inspection.12/9/2013 Same as last inspection.7/10/2013 WS slope is cleared of vegetation and is in good condition. LS screw gate frame is twisted and is preventing the gate from opening.4/19/2012 Limited inspection dense vegetation on WS. Need photos of clear WS slope & toe. Ditch present in channel? This crossing was listed in the USACE Periodic Inspection report as Corp's Inspect ID# USACE_CESPK_M13G_2011_p_0108 for WS flap gate filled with soil and LS gate not functioning because of overgrown vegetation. FIELD_STRUCT_DESC: 24-inch corrugated metal drainage pipe through the levee, 7.9 feet below the crown. Concrete "U" headwalls on both waterside (WS) and landside (LS) ends. Flap gate on the WS end. Slide gate at the LS toe in headwall. In 1962, permit number 3953 was issue for existing pump structure, intake box, ditch and power pole. In 1963, the pump and intake box were removed. (Permit No. 3953, 1960 - Dr. John O. Gibbs, DBA Empire Land Company) [Additional Reference(s): DWR Levee Log, 1993. USACE Sacramento O&M Manual 519, June 1962 (HLM 1.70)]

Overview of crossing

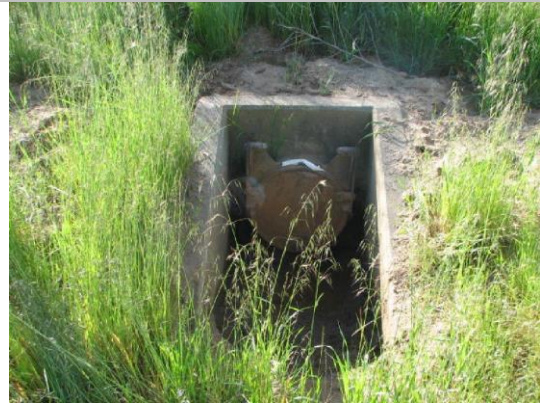
Photo 2 of 3 : UCIP_SP_2018_52114_67058.jpg

FS_ID:52114
DS_ID:16399
EP_NO: N/A
Repair Type: Non-Urgent
Crossing Status: Found
UCIP Comments: 6/5/2017 LS slide gate stem is bent and the gate appears as if it will not open. LS inlet is becoming heavily vegetated next to rice field. WS flap gate is blocked shut by sediment. Pipe has been selected to be internally cleaned and inspected as part of the DMP project. (DWR Sutter Yard- A Freitag)11/18/2016 LS screw gate still bent and in-operable. (DWR Sutter Yard- A Freitag)4/27/2016 LS screw gate is still bent. Rest of crossing appeared in good condition.7/01/2015 LS screw gate frame is still twisted and hindering the gate from opening.5/29/2014 Same as last inspection.12/9/2013 Same as last inspection.7/10/2013 WS slope is cleared of vegetation and is in good condition. LS screw gate frame is twisted and is preventing the gate from opening.4/19/2012 Limited inspection dense vegetation on WS. Need photos of clear WS slope & toe. Ditch present in channel? This crossing was listed in the USACE Periodic Inspection report as Corp's Inspect ID# USACE_CESPK_M13G_2011_p_0108 for WS flap gate filled with soil and LS gate not functioning because of overgrown vegetation. FIELD_STRUCT_DESC: 24-inch corrugated metal drainage pipe through the levee, 7.9 feet below the crown. Concrete "U" headwalls on both waterside (WS) and landside (LS) ends. Flap gate on the WS end. Slide gate at the LS toe in headwall. In 1962, permit number 3953 was issue for existing pump structure, intake box, ditch and power pole. In 1963, the pump and intake box were removed. (Permit No. 3953, 1960 - Dr. John O. Gibbs, DBA Empire Land Company) [Additional Reference(s): DWR Levee Log, 1993. USACE Sacramento O&M Manual 519, June 1962 (HLM 1.70)]

View of flap gate on WS.

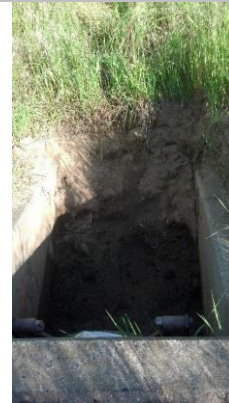
Photo 3 of 3 : UCIP_SP_2018_52114_67057.jpg

FS_ID:52114
DS_ID:16399
EP_NO: N/A
Repair Type: Non-Urgent
Crossing Status: Found
UCIP Comments: 6/5/2017 LS slide gate stem is bent and the gate appears as if it will not open. LS inlet is becoming heavily vegetated next to rice field. WS flap gate is blocked shut by sediment. Pipe has been selected to be internally cleaned and inspected as part of the DMP project. (DWR Sutter Yard- A/Freitag)11/18/2016 LS screw gate still bent and in-operable. (DWR Sutter Yard- A/Freitag)4/27/2016 LS screw gate is still bent. Rest of crossing appeared in good condition.7/01/2015 LS screw gate frame is still twisted and hindering the gate from opening.5/29/2014 Same as last inspection.12/9/2013 Same as last inspection.7/10/2013 WS slope is cleared of vegetation and is in good condition. LS screw gate frame is twisted and is preventing the gate from opening.4/19/2012 Limited inspection dense vegetation on WS. Need photos of clear WS slope & toe. Ditch present in channel? This crossing was listed in the USACE Periodic Inspection report as Corp's Inspect ID# USACE_CESPK_M13G_2011_p_0108 for WS flap gate filled with soil and LS gate not functioning because of overgrown vegetation. FIELD_STRUCT_DESC: 24-inch corrugated metal drainage pipe through the levee, 7.9 feet below the crown. Concrete "U" headwalls on both waterside (WS) and landside (LS) ends. Flap gate on the WS end. Slide gate at the LS toe in headwall. In 1962, permit number 3953 was issue for existing pump structure, intake box, ditch and power pole. In 1963, the pump and intake box were removed. (Permit No. 3953, 1960 - Dr. John O. Gibbs, DBA Empire Land Company) [Additional Reference(s): DWR Levee Log, 1993. USACE Sacramento O&M Manual 519, June 1962 (HLM 1.70)]

View of WS toe.

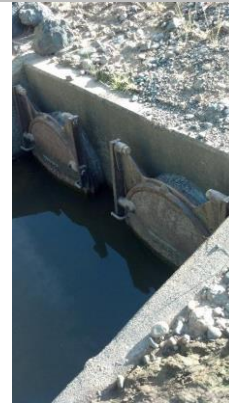
Photo 3 of 3 : UCIP_SP_2018_52115_67064.jpg

FS_ID:52115
DS_ID:16400
EP_NO: N/A
Repair Type: No Action Needed
Crossing Status: Found
UCIP Comments: 6/5/2017 LS inlet was underwater. WS flapgate blocked shut by sediment. Pipe has been selected to be internally cleaned and inspected as part of the DMP project. (DWR Sutter Yard-AFreitag)11/18/2016 Sediment dug out from in front of flap gate. Gate can now function properly. (DWR Sutter Yard-AFreitag)4/27/2016 WS flapgate still blocked from opening by sediment buildup.7/01/2015 New screwgate installed on the LS. WS flapgate is still blocked from opening by sediment.5/29/2014 Same as last inspection.12/9/2013 Same as last inspection.7/10/2013 Sediment is built up against WS flap gate not allowing it to open. Handle for LS slide gate is still missing.4/19/2012 Handle missing on slide gate.
FIELD_STRUCT_DESC: 1 of 2: 36-inch corrugated metal drainage pipe through the levee, 9.7 feet below the crown. Concrete "U" headwalls located on the waterside (WS) and landside (LS) ends. Flap gate on the WS end. Slide gate on the LS end. [Additional Reference(s): DWR Levee Log, 1993. USACE Sacramento O&M Manual 519, June 1962 (HLM 2.54)]

Headwall and flap gates (2) located on WS

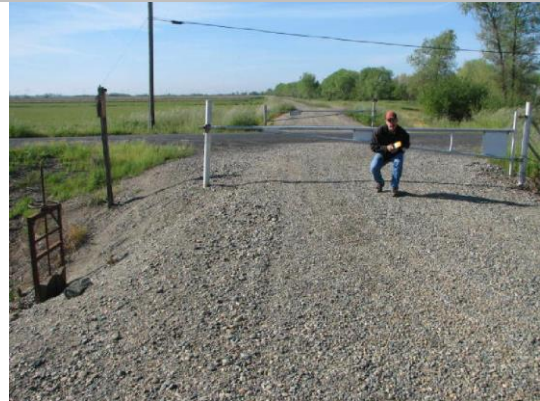
Photo 1 of 3 : UCIP_SP_2018_52117_67077.jpg

FS_ID:52117
DS_ID:16402
EP_NO: N/A
Repair Type: Non-Urgent
Crossing Status: Found
UCIP Comments: 6/5/2017 Sediment blocking LS slide gate from closing fully. Pipe has been selected to be internally cleaned and inspected as part of the DMP project. (DWR Sutter Yard-AFreitag)11/18/2016 Sediment still blocking screw gate from fully closing. (DWR Sutter Yard- AFreitag)4/27/2016 LS slide gate is full of sediment and needs to be dug out so gate can close fully.7/01/2015 LS screwgate is still silted in and unable to be screwed down all the way. Needs to be cleaned out.5/29/2014 Same as last inspection.12/9/2013 WS flapgate was closed but LS slidegate is heavily vegetated and blocked from closing by sediment.7/10/2013 Same as last inspection.4/19/2012 Minor sediment built up on LS, remove sediment. Need photo of LS slide gate without sediment build up. This crossing was listed in the USACE Periodic Inspection report as Corp's inspect ID# USACE_CESPK_M13G_2011_p_0148 for LS gate obstructed by vegetation and WS flap gate is not functioning (propped open).

Overview looking south from left levee

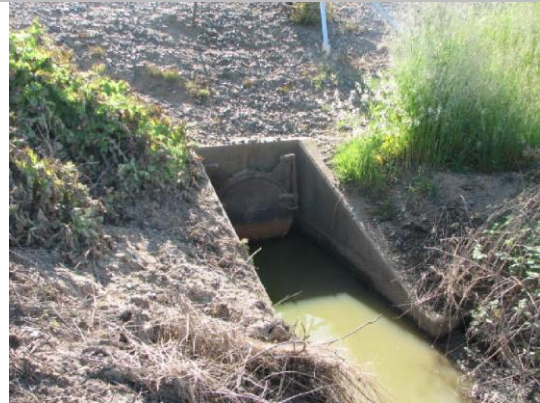
Photo 2 of 3 : UCIP_SP_2018_52117_67076.jpg

FS_ID:52117
DS_ID:16402
EP_NO: N/A
Repair Type: Non-Urgent
Crossing Status: Found
UCIP Comments: 6/5/2017 Sediment blocking LS slide gate from closing fully. Pipe has been selected to be internally cleaned and inspected as part of the DMP project. (DWR Sutter Yard-AFreitag)11/18/2016 Sediment still blocking screw gate from fully closing. (DWR Sutter Yard- AFreitag)4/27/2016 LS slide gate is full of sediment and needs to be dug out so gate can close fully.7/01/2015 LS screwgate is still silted in and unable to be screwed down all the way. Needs to be cleaned out.5/29/2014 Same as last inspection.12/9/2013 WS flapgate was closed but LS slidegate is heavily vegetated and blocked from closing by sediment.7/10/2013 Same as last inspection.4/19/2012 Minor sediment built up on LS, remove sediment. Need photo of LS slide gate without sediment build up. This crossing was listed in the USACE Periodic Inspection report as Corp's inspect ID# USACE_CESPK_M13G_2011_p_0148 for LS gate obstructed by vegetation and WS flap gate is not functioning (propped open).

Headwall and flap gate located on WS.

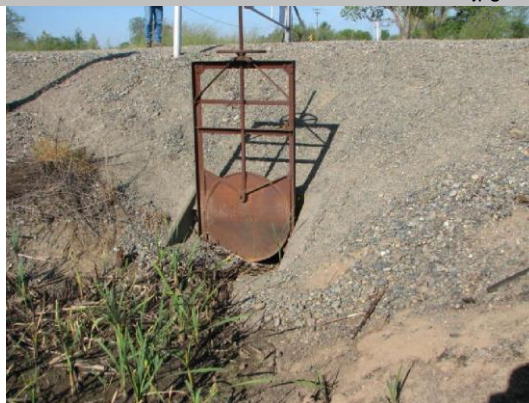
Photo 3 of 3 : UCIP_SP_2018_52117_67078.jpg

FS_ID:52117
DS_ID:16402
EP_NO: N/A
Repair Type: Non-Urgent
Crossing Status: Found
UCIP Comments: 6/5/2017 Sediment blocking LS slide gate from closing fully. Pipe has been selected to be internally cleaned and inspected as part of the DMP project. (DWR Sutter Yard-AFreitag)11/18/2016 Sediment still blocking screw gate from fully closing. (DWR Sutter Yard- AFreitag)4/27/2016 LS slide gate is full of sediment and needs to be dug out so gate can close fully.7/01/2015 LS screwgate is still silted in and unable to be screwed down all the way. Needs to be cleaned out.5/29/2014 Same as last inspection.12/9/2013 WS flapgate was closed but LS slidegate is heavily vegetated and blocked from closing by sediment.7/10/2013 Same as last inspection.4/19/2012 Minor sediment built up on LS, remove sediment. Need photo of LS slide gate without sediment build up. This crossing was listed in the USACE Periodic Inspection report as Corp's inspect ID# USACE_CESPK_M13G_2011_p_0148 for LS gate obstructed by vegetation and WS flap gate is not functioning (propped open).

Headwall and screw gate located on LS.

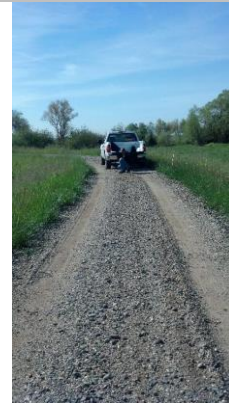
Photo 1 of 3 : UCIP_SP_2018_52121_67094.jpg

7/10/2013 LS and WS slopes have been cleared by vegetation and are in good condition. WS flap gate is out of water but is blocked from opening by sediment build up. LS gate is fully submerged and not able to be inspected.4/19/2012 Non-functioning crossing. Farmer uses pipe located at LM 3.682 to drain field & not this one. Dense vegetation-need photos of cleared WS & LS slopes. This crossing was listed in the USACE Periodic Inspection report as Corp's inspect ID# USACE_CESPK_M13G_2011_p_0172 for no access to WS gate due to high water & dense vegetation.

Overview looking south from left levee
